Inspection of Minnesota Pipelines MPL1, MPL2, & MPL4

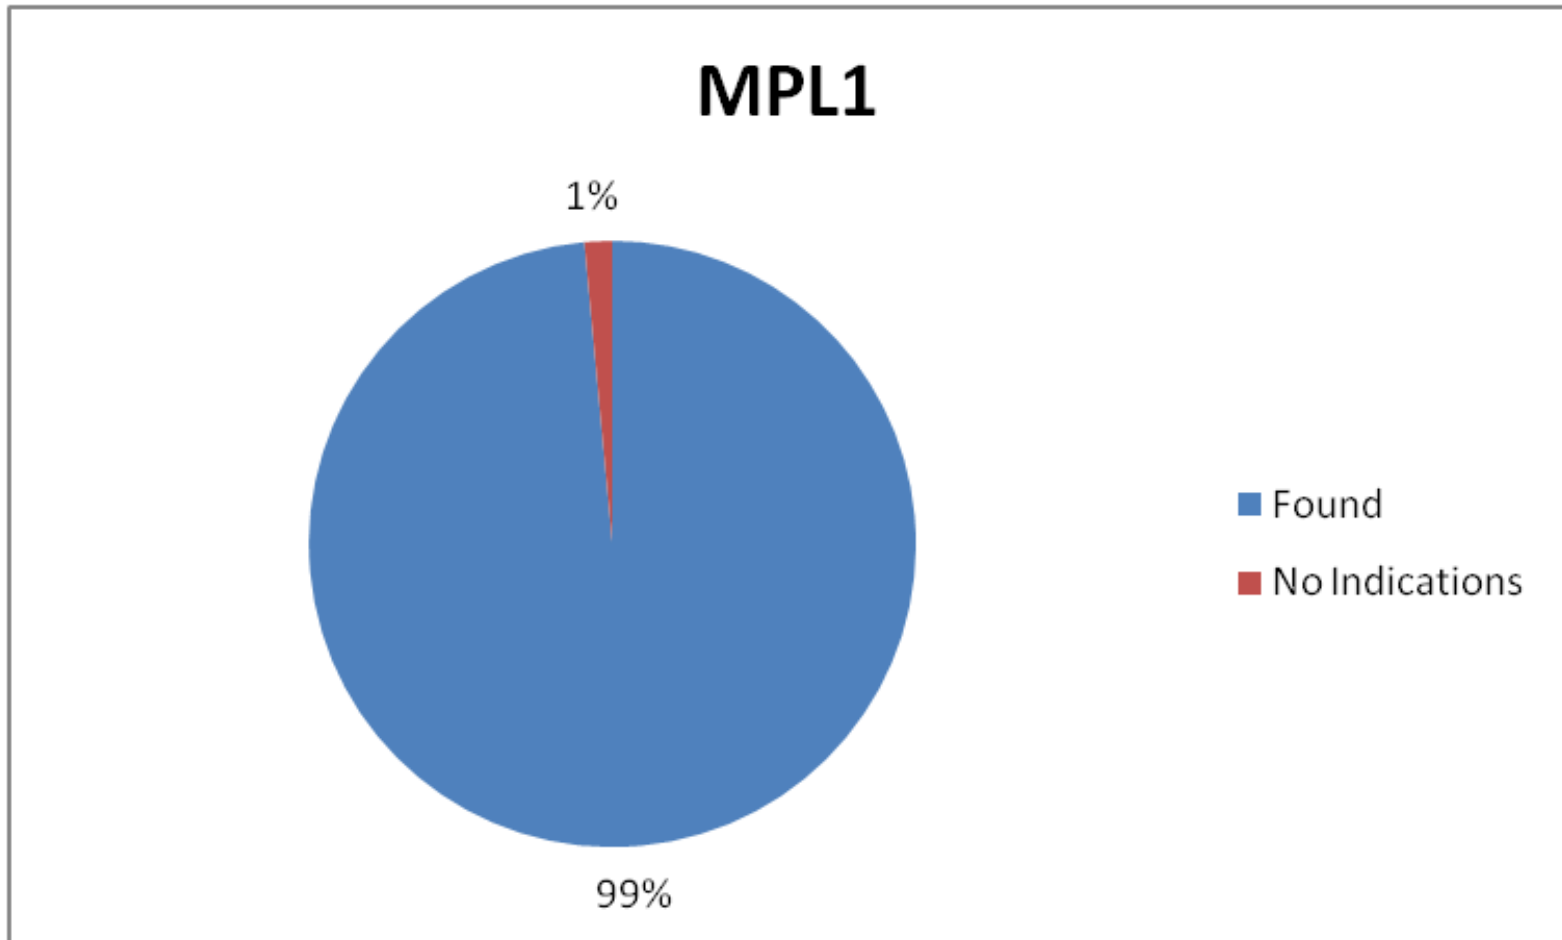
- Confirmation of features called

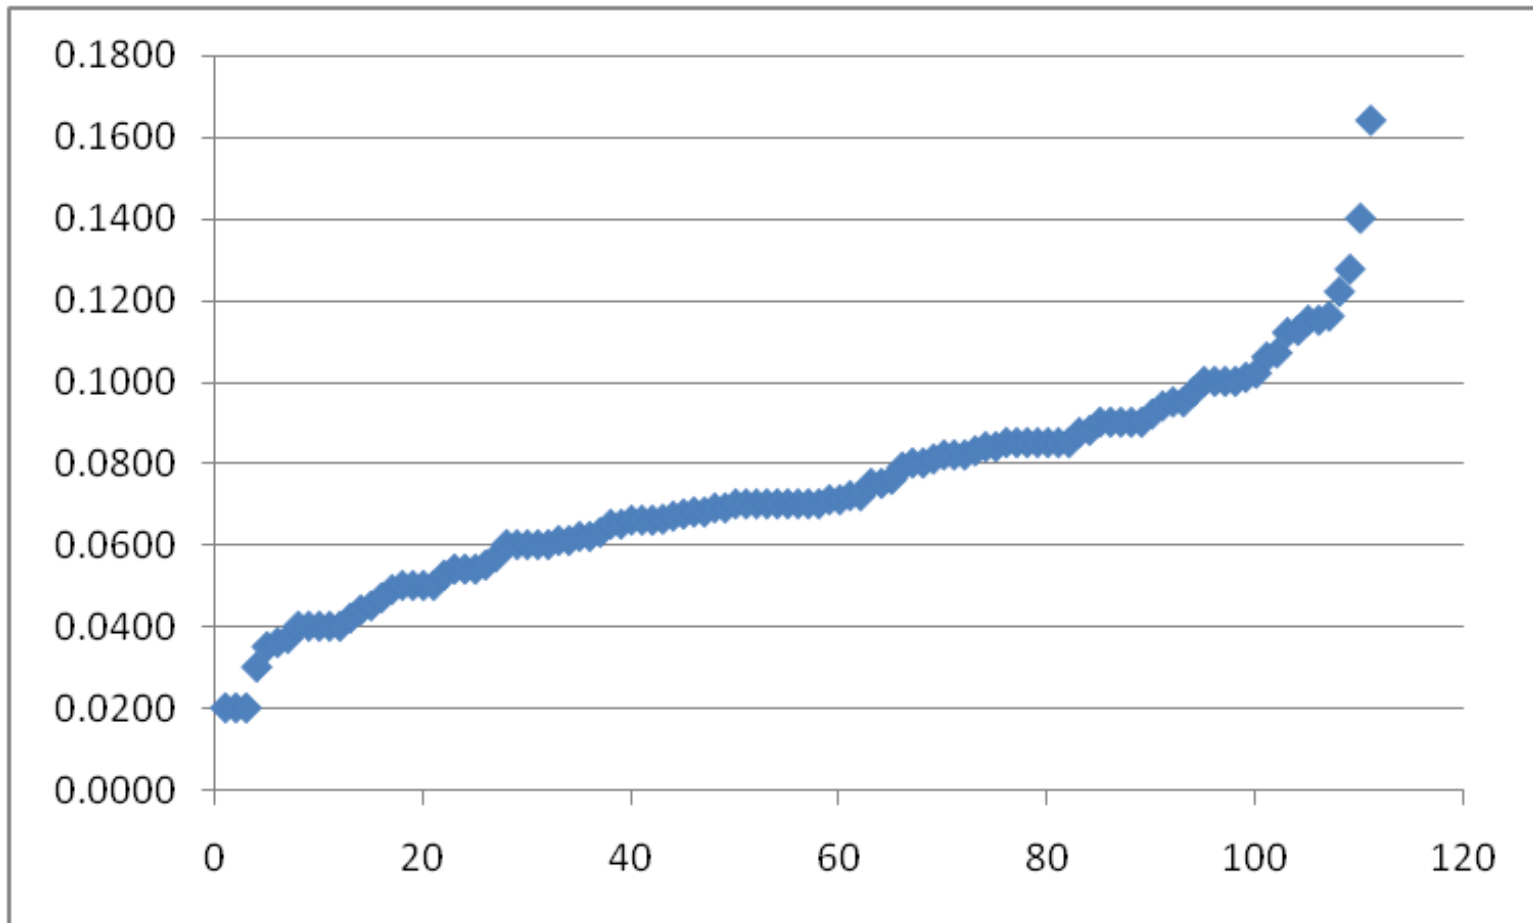
- As-called depth vs. as-found depth (40-80 mil range)

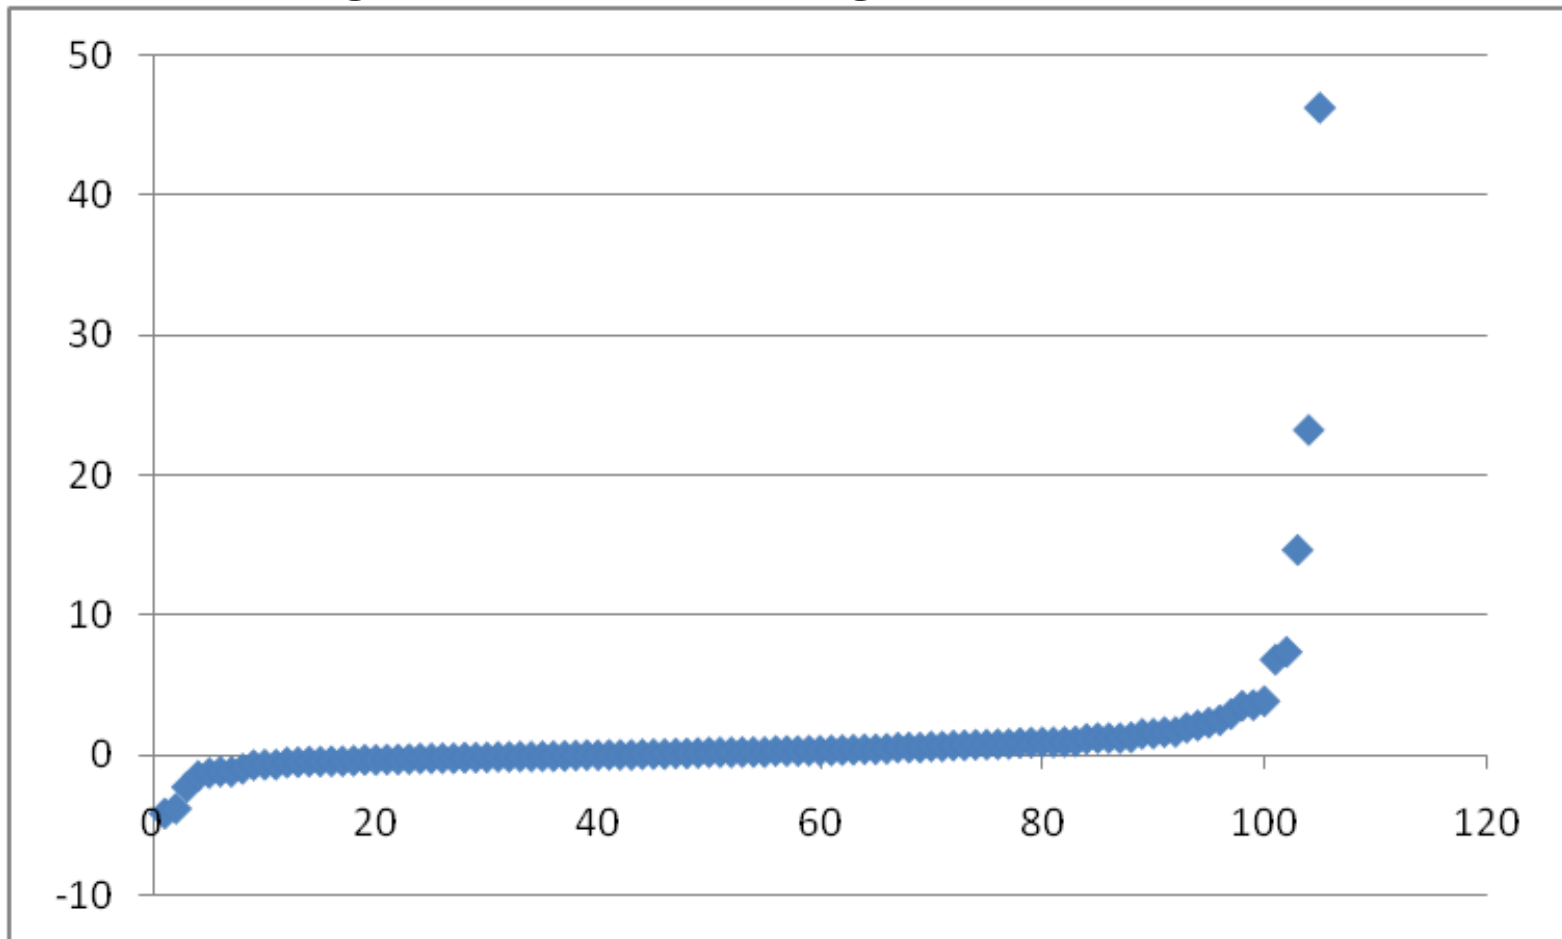
- As-called length vs. as-found length

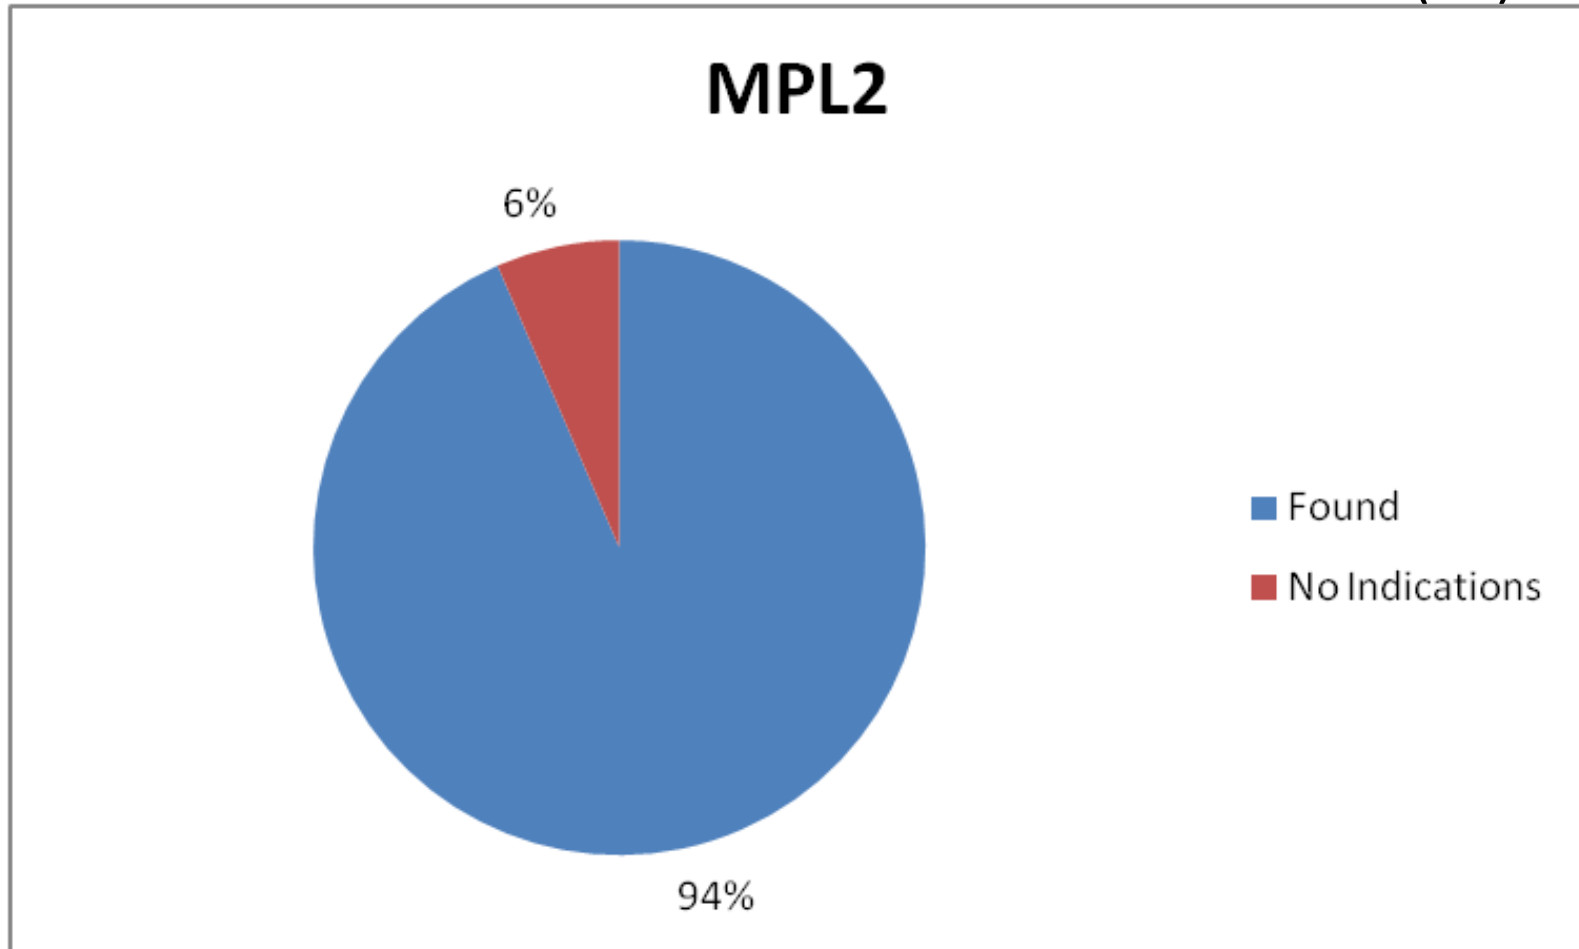
- Confirmation of features as-called vs. field-evaluated (59)

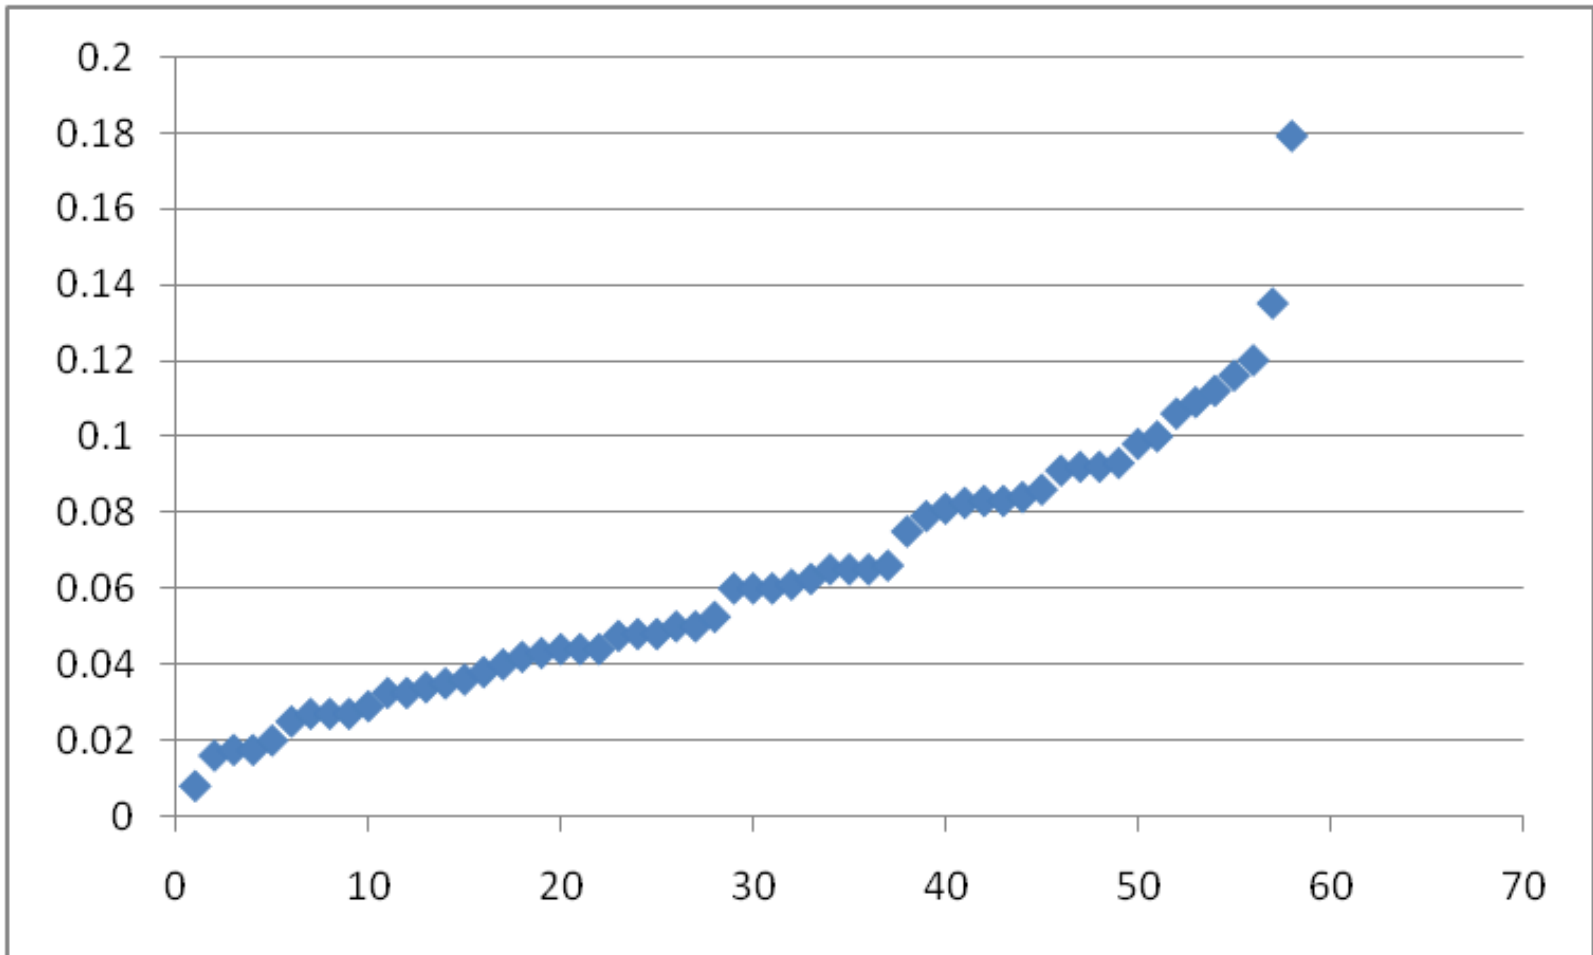
- As-called depth vs. as-found depth (40-80 mil range) for field-evaluated features (59)

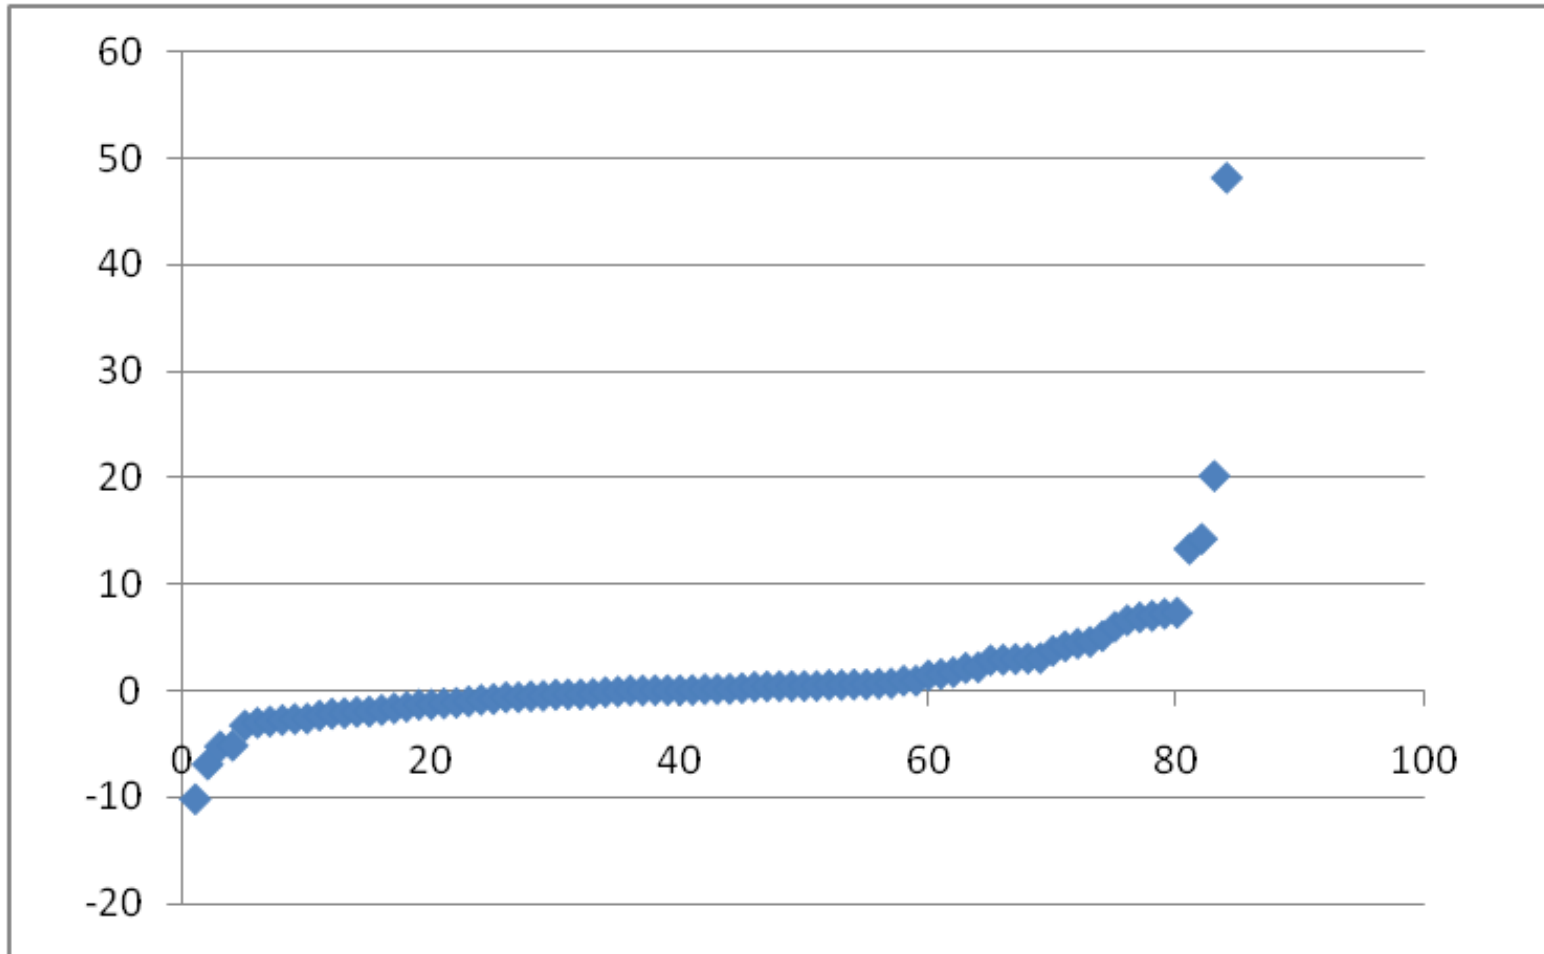
- As-called length vs. as-found length for field-evaluated features (59)

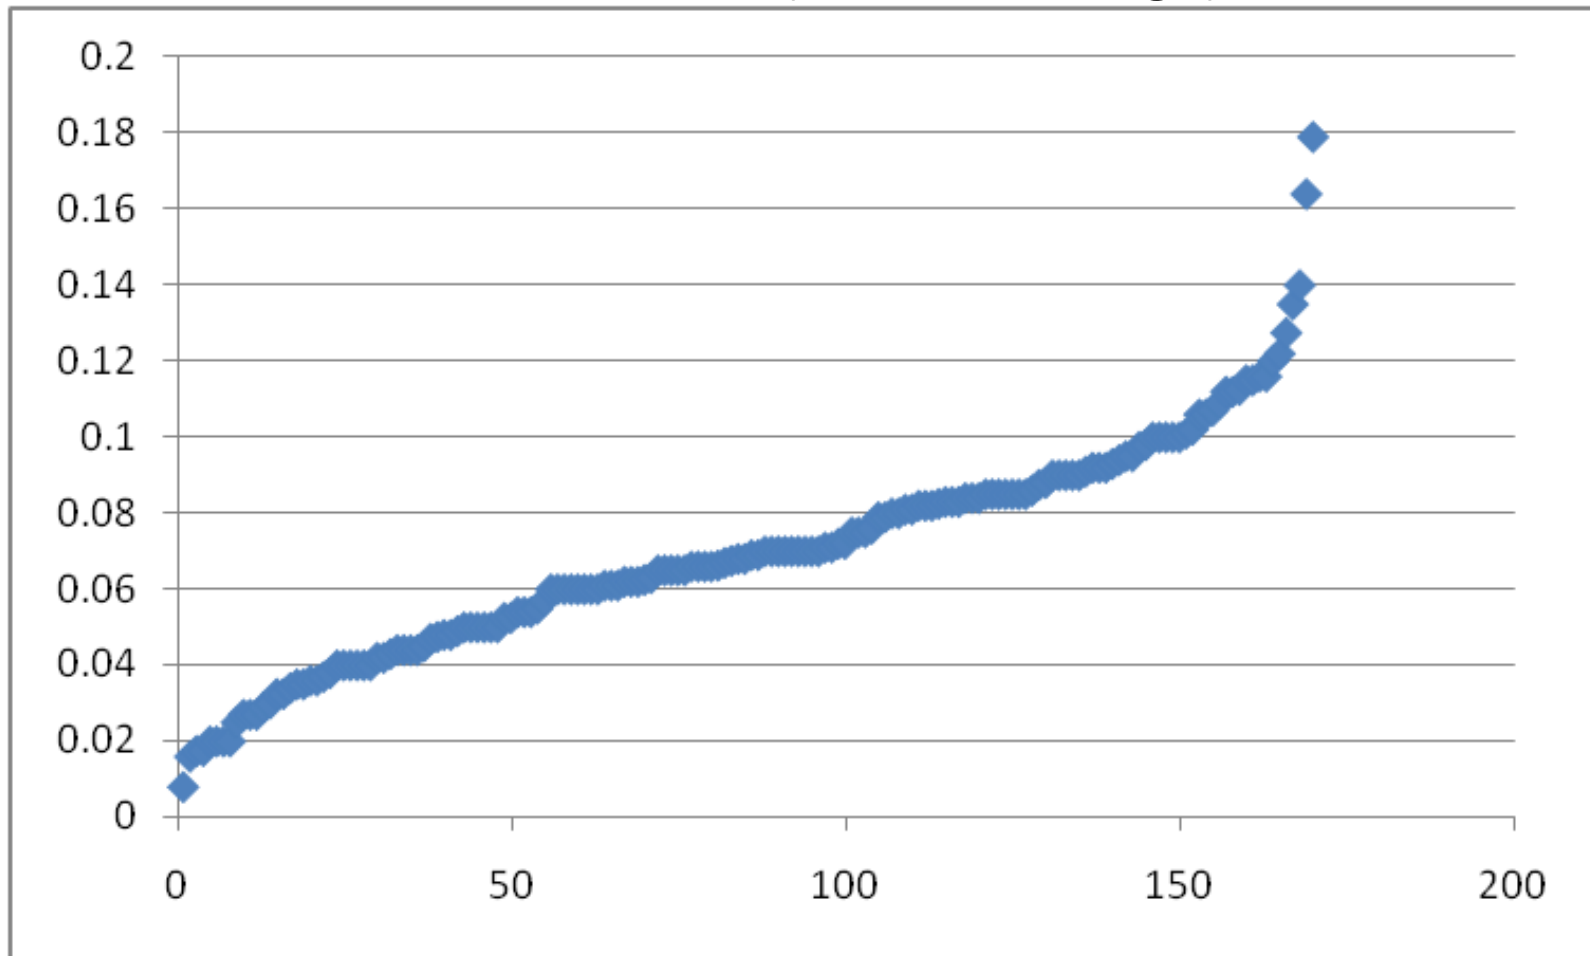
- Predicted vs. field-evaluated (40-80 mil range)

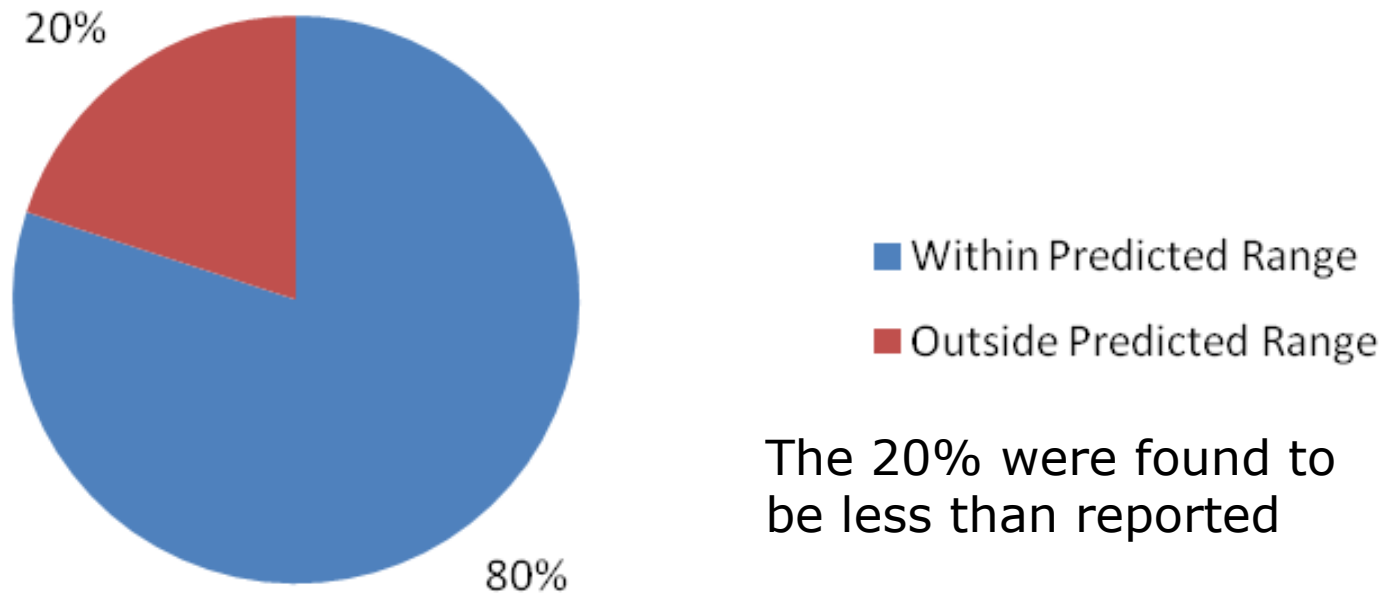
80-160
>160

The 20% were found to be less than reported

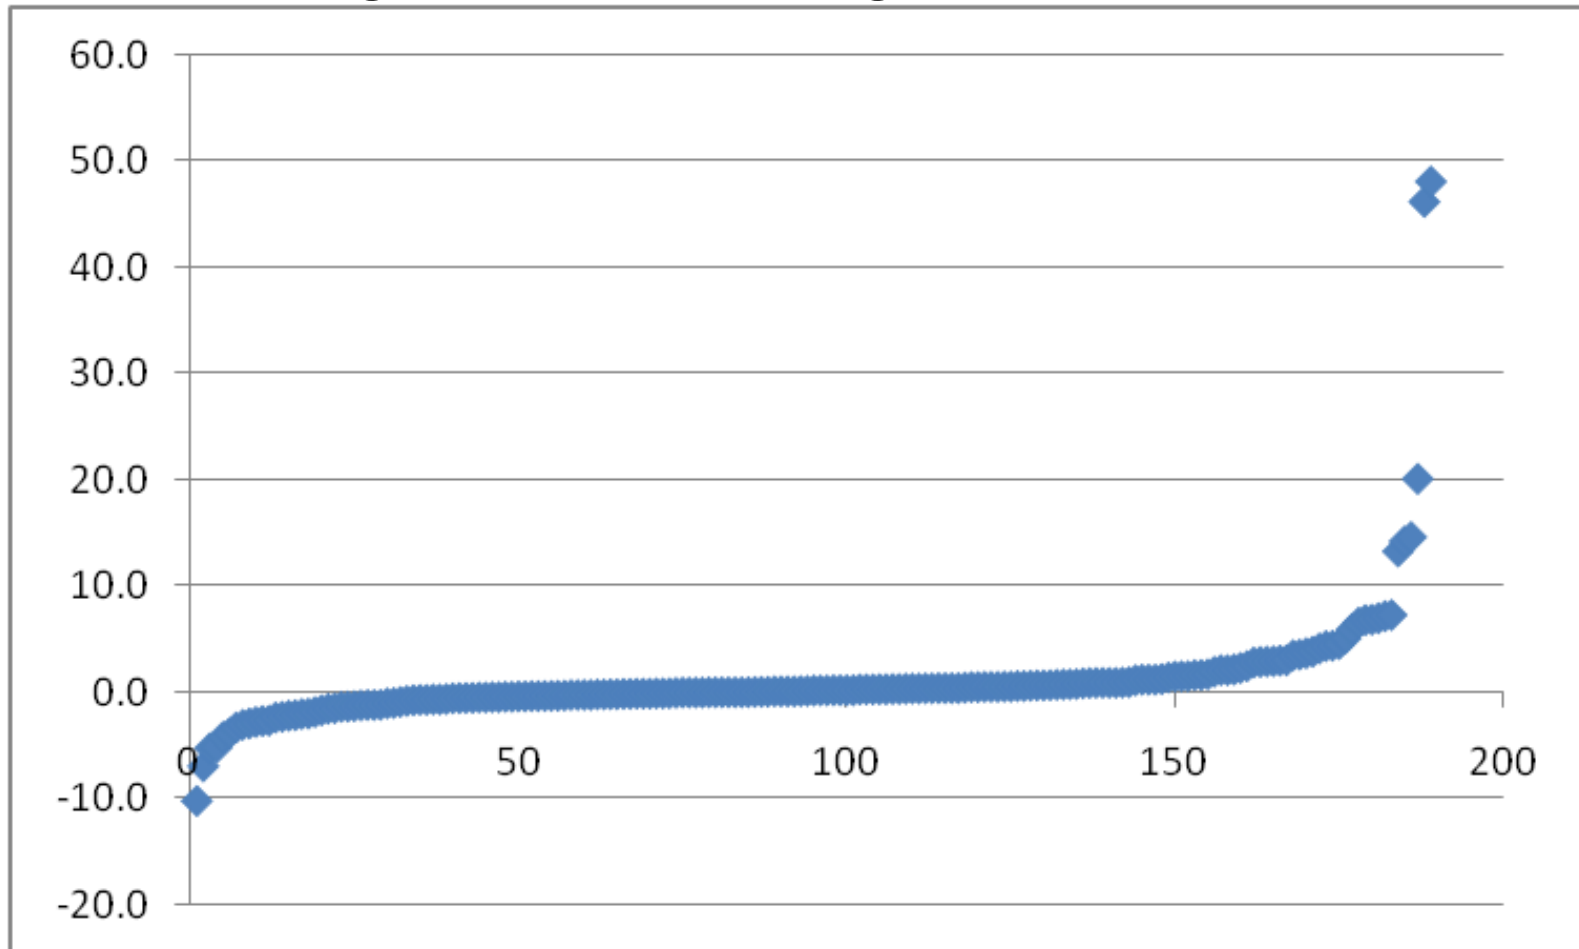
- As-called length vs. as-found length
