Inspection of Minnesota Pipelines MPL1, MPL2, & MPL4

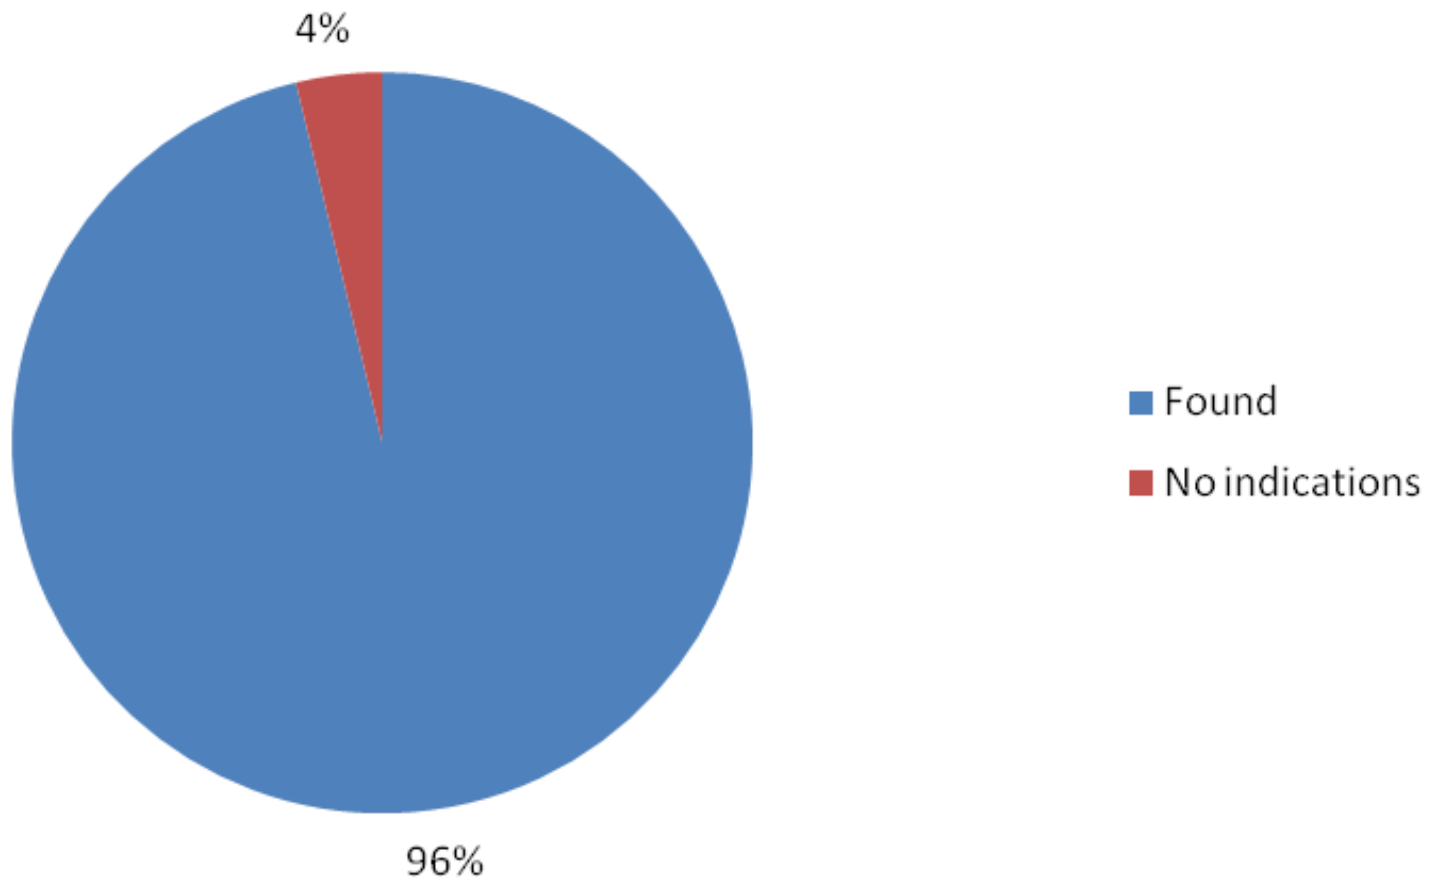
Combined MPL1 and MPL2 Field Verification Findings

- Predicted vs. field-evaluated (40-80 mil range)

The 20% were found to be less than reported
